GREAT AMERICAN LEVEES

A
COMPARATIVE
REPORT *on* FLOOD
PROTECTION *in*
the MISSISSIPPI *and*
SACRAMENTO VALLEYS
MADE *for the*
WEST SACRAMENTO
COMPANY

by
HAVILAND DOZIER & TIBBETTS
Civil & Consulting Engineers - ISSUED by
WEST SACRAMENTO COMPANY
SACRAMENTO

REPORT - ON - MISSISSIPPI - RIVER FLOOD - CONDITIONS - OF - 1912

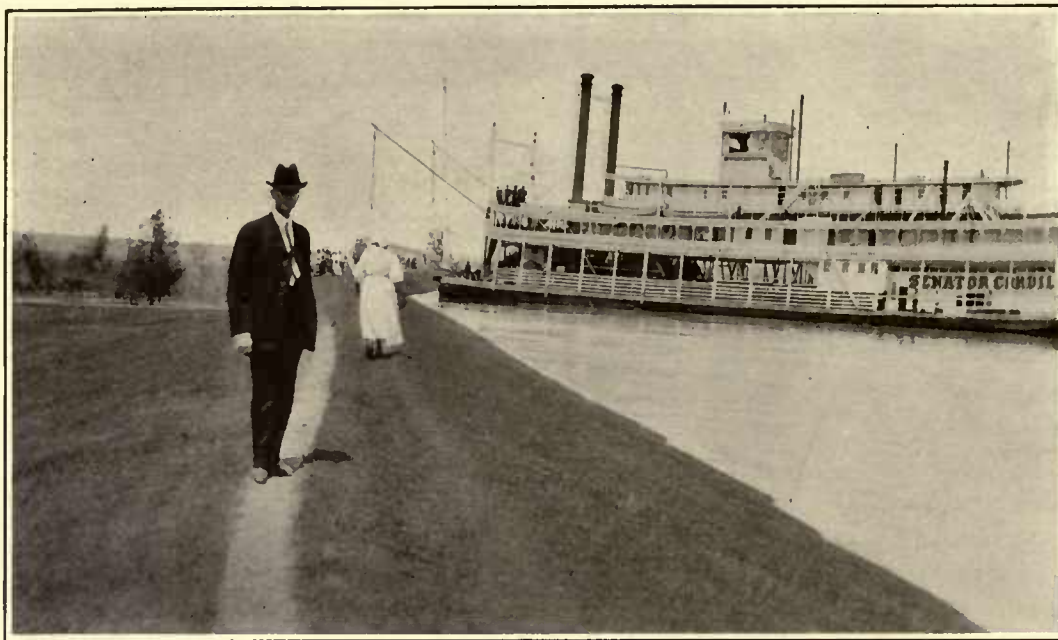
FIGURE 1 — Standard government levee
at Lake St. John, La. Levee 22 feet high with
banquette on rear.

cross section has been developed by long experience and is expected to withstand the water to within 3 feet of the crown, for long periods without excessive saturation or change of forms, and to give unqualified protection under any normal conditions of foundation and materials of construction. It is not believed that in the 1912 flood there were any important failures in levees of the standard cross section, unless the water got higher than 3 feet below the crown, except through defective foundations. The standard cross section is shown on Section 1, Plate 2. It has an 8-foot top width, with 1 on 3 side slopes to the ground level on the water side, and on the land side, down to a point 8 feet from the top, at which point a banquette is added with a 1 on 10 slope for 20 feet, after which the slope is 1 on 4 to the ground level. (See Figs. 1 and 2.)

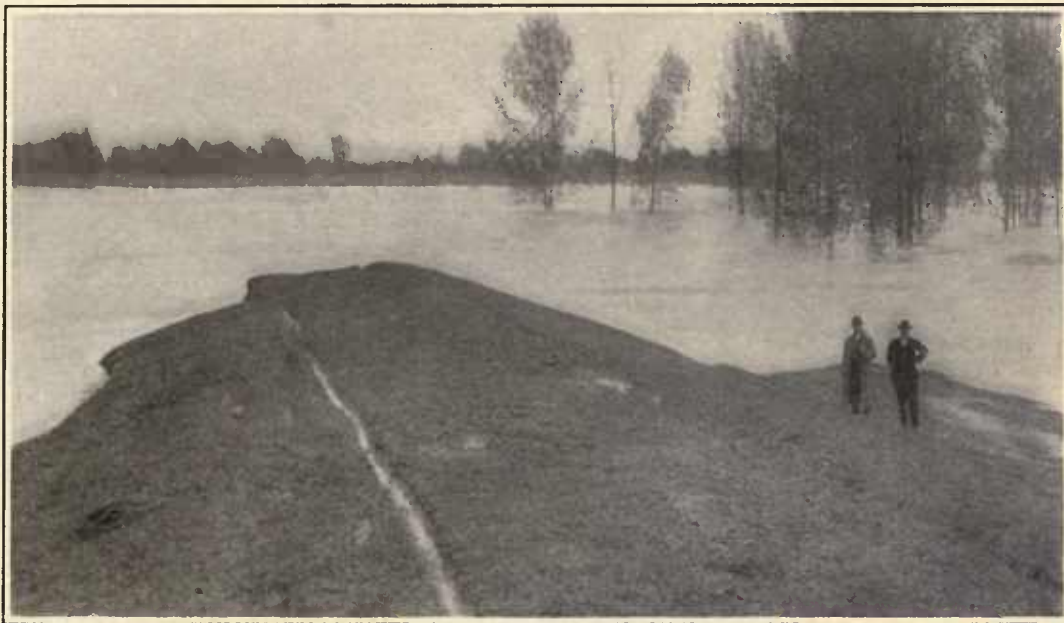
FIGURE 2—Standard government levee.
Lower Tensas District at Alsatia Break. Spectators
standing on banquette at rear.

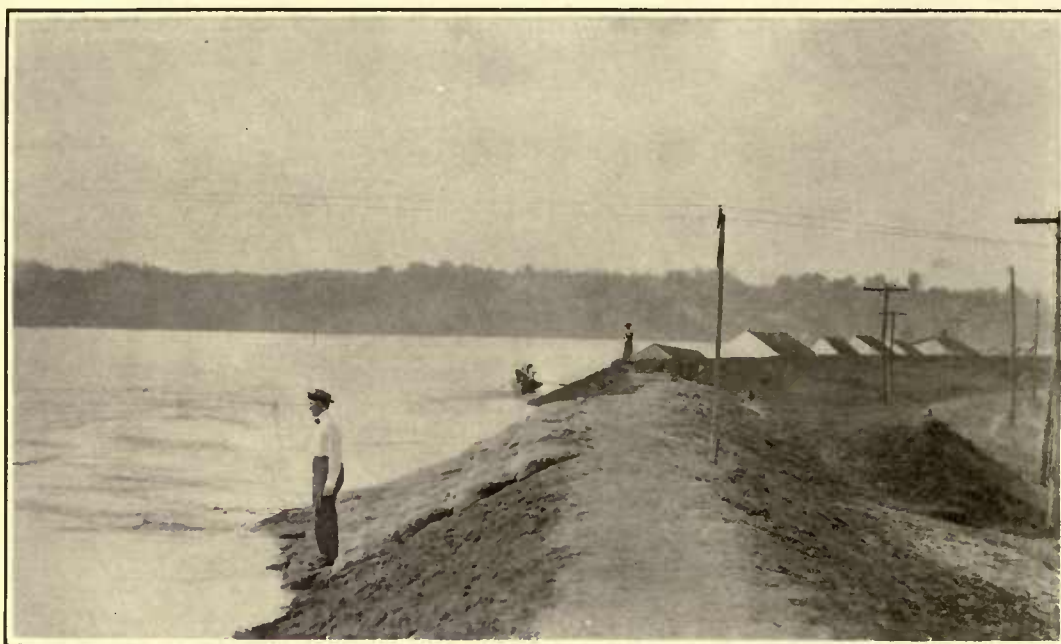
FIGURE 3—Levee at Vidalia, La.
Eddy formed at location of traverse on berm. Sack revetment
to prevent undermining.

no continuous holes or lines of weakness in the foundation. The borrow pits are interrupted by traverses with a minimum top width of 10 feet and side slopes of 1 on 2. The traverses are left normal to the levee, at intervals of not more than 500 feet, to prevent the flow of a current along the base of the levee. (See Fig. 3.)

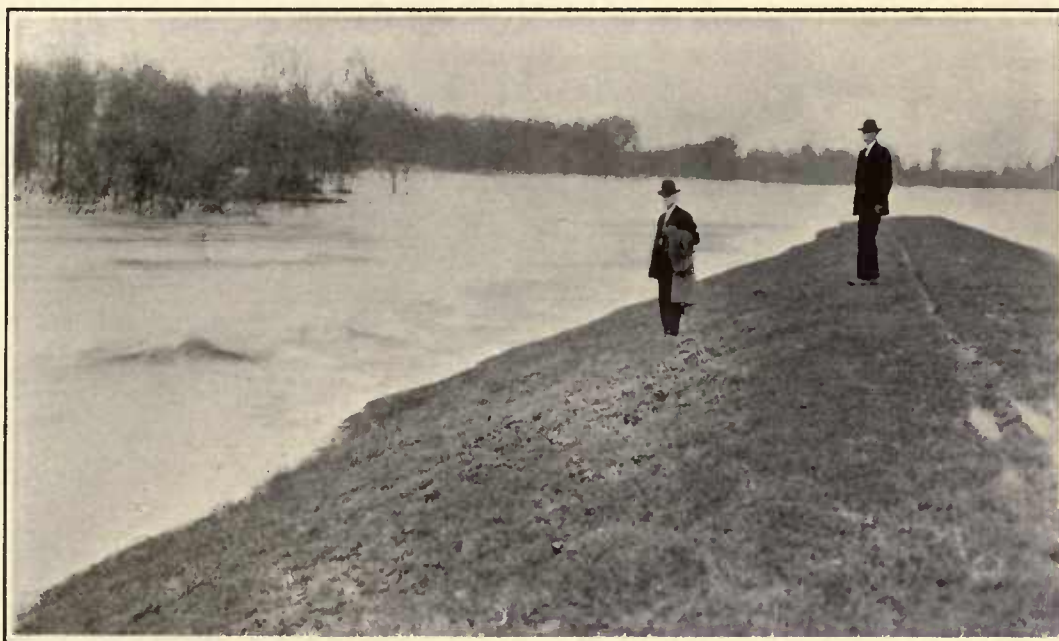
FIGURE 4—Edge of great crevasse at Alsatia, La. One of the largest and most disastrous breaks in the history of the Mississippi River. Break about 5000 feet long; water running about 15 feet deep. Flooded the entire Tensas Valley.

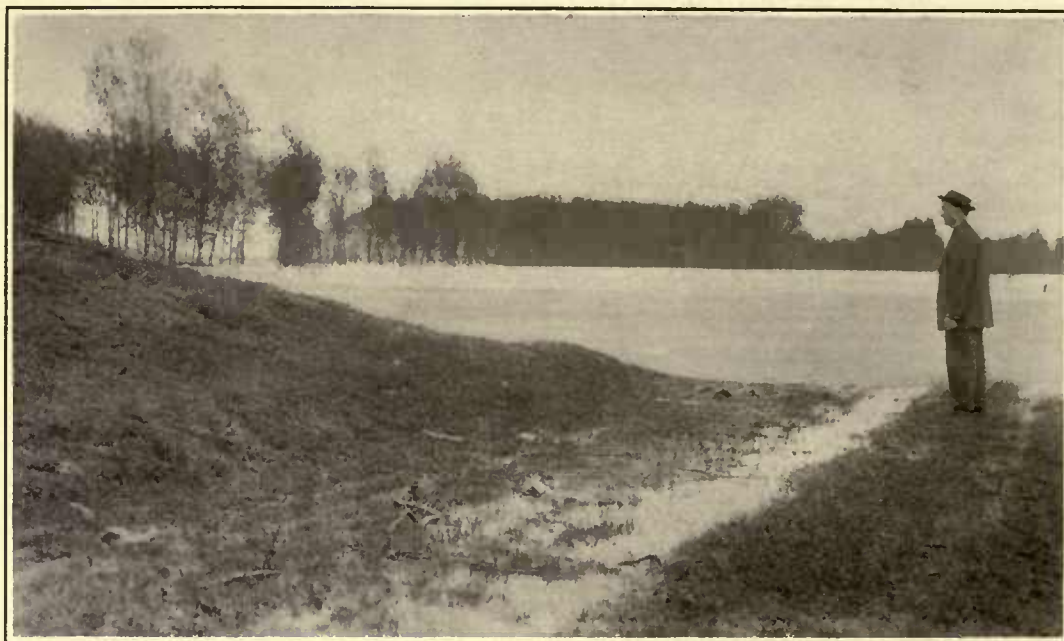
FIGURE 5 — Rear edge at south end of big crevasse at Alsatia or Salem, La., about 50 miles above Vicksburg, Tenn. Break occurred at junction of old and new levee. Levee was 22 feet high and holding 17 feet of water. Break occurred by a sand-boil suddenly appearing at the rear toe. The levee was considered safe. A stream of water 2 feet in diameter was reported to be running through the sand-boil, just prior to the collapse of the levee.

seepage finds its way through in increasing quantities and may make its appearance in concentrated form on the banquette, at the rear toe of the levee, or a considerable distance beyond the rear toe of the levee. When the seepage becomes concentrated, and especially if it is muddy, indicating that it is washing material from the levee section, it is a serious indication of approaching failure. "Sand-boils" or "blow-outs" are thus caused. If the seepage is allowed to continue until a well-defined stream comes through the rear of the levee, a hole is soon washed completely through, and the levee caves in with disastrous results. Where the levees are comparatively low and carefully patrolled, this is sometimes checked by dumping in material, preferably clay, on the outer slope which may be drawn in to the weakened portions, thus checking the seepage. In general, however, the best method of treatment is to surround spots where seepage concentrates in an alarming fashion, with a wall of earth, or to encircle or loop them with sacks of earth. The retaining work must be carried up to a sufficient height to overcome the head of water on the outside. When a leak of this sort appears at the base of the levee or on the rear slope, accompanied by the flowing or boiling up of sand, no time should be lost in commencing emergency work. (See Fig. 5.)

Where, due to defective foundations, sand-boils are numerous, the most effective method of treatment is to enlarge the banquette, or to build sub-levees.

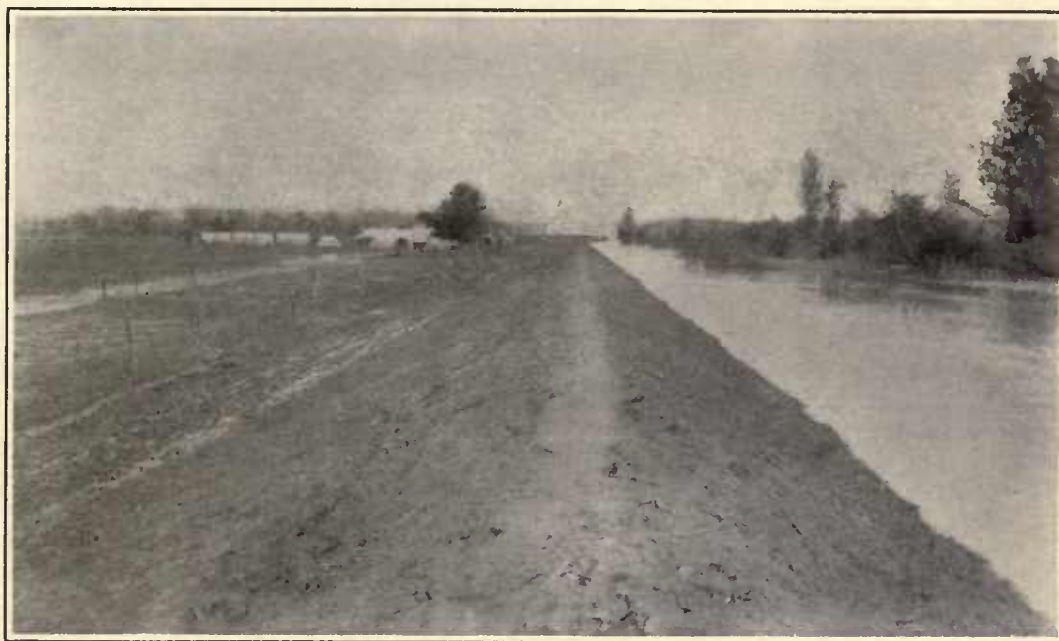
FIGURE 6—Levee at Vidalia, La., opposite Natchez, Miss. Saturated rear slope is beginning to slough off. Water within 1 foot of crown of levee which has been raised 3 feet by earth topping. Sloughing in rear of levee near center of view. Contractor's emergency camp in background.

complete saturation passes through the levee so that seepage appears in any considerable amounts on the rear face, sloughing is apt to occur. (See Fig. 6.)

It is believed that more thorough drainage of the levees would check this wide-spread tendency along the Mississippi River. There are many cases in which a line of tile is placed underneath the rear toe and many others in which a small hand ditch is located at or near the rear toe. Both of these methods are designed to collect seepage water and lead it away from the levees to the adjacent fields. When properly constructed, drainage of this sort is very efficient in preventing the saturation of the rear slope. It may even be used with highly beneficial results as emergency work, when it is evident that the rear slope is becoming actually saturated. When sloughing occurs, the most common emergency work is to add dead weight near the base of the rear slope, usually by first covering the saturated surface with a coarse layer of brush or straw and then weighting with sacks of earth, sand, or other convenient material. (See Plate 3 and Figs. 7 and 8.)

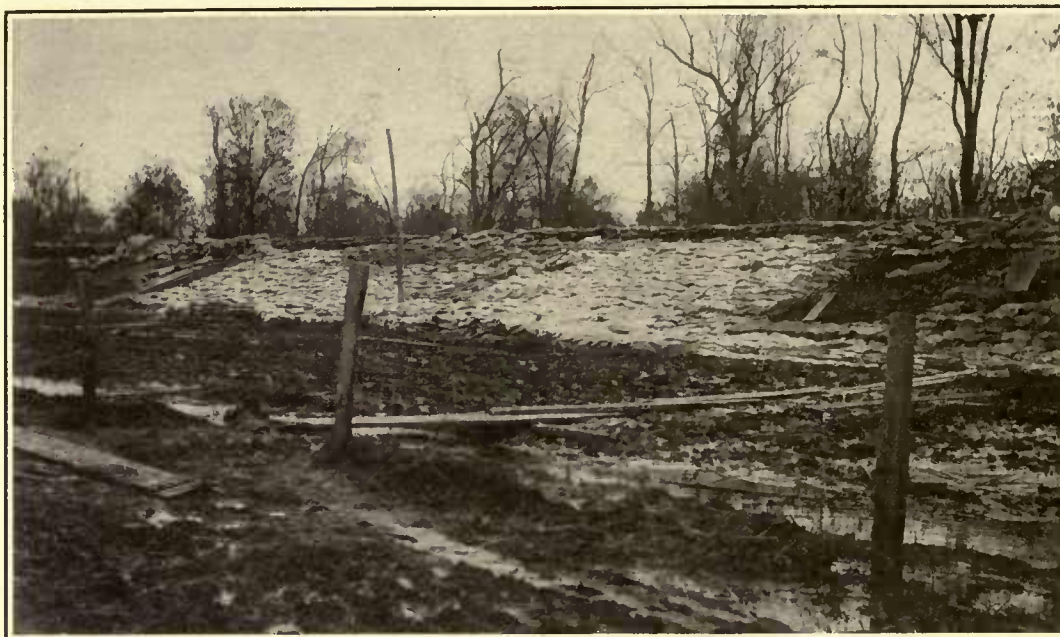
FIGURE 7—Brush and sack revetment, Blytheville, Ark. Here the sack topping is fully 2 feet above the levee. The slope has become so saturated that the heavy brush and sack revetment was applied to keep it from sloughing away. (By courtesy of Mr. A. L. Dabney.)

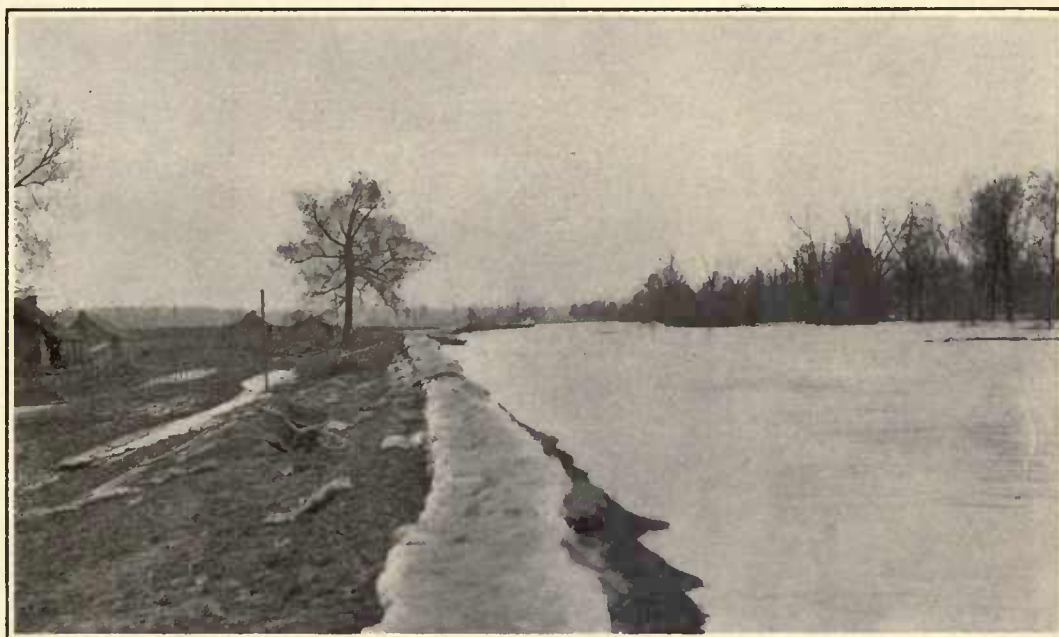
FIGURE 8—Sack revetment and sack topping near Memphis, Tenn. (By courtesy of Mr. A. L. Dabney.)

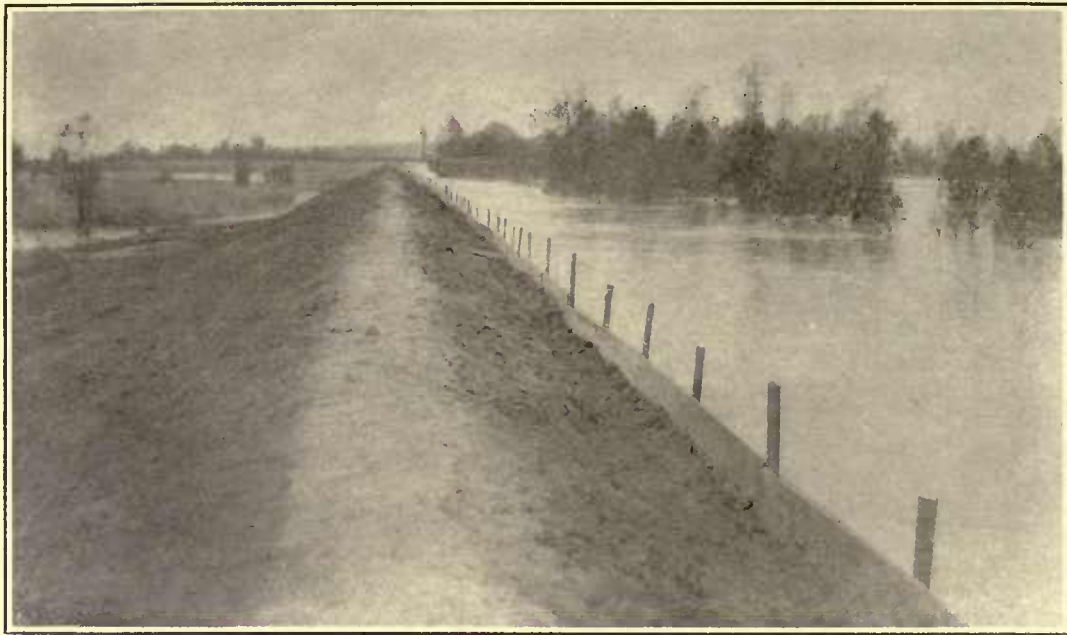
FIGURE 9—Earth topping on levees at Vidalia, above Natchez, Miss.; levee raised 2 feet with fresh earth placed with wheelbarrows. Wash-boards to protect from wave action. Crown width 2 feet.

by the action of waves breaking at the vertical face, projecting the force of the water downward at the toe of the protection work. (See Fig. 9.)

extended to a height of 3 feet as shown on Section 1, Plate 4, giving the fresh material 1 on 1½ side slopes, and a 2-foot crown width. (See Fig. 9.)

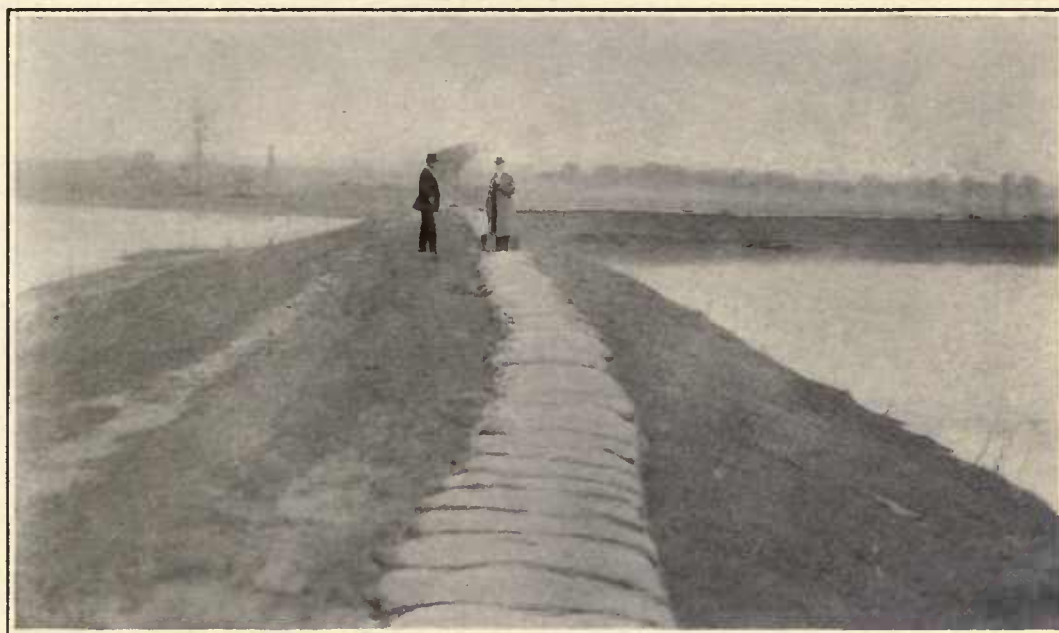
FIGURE 10—Levees of lower Yazoo District near Brunswick, Miss., topped with sacking, partially backed with earth (water has fallen as a result of the Alsatia break).

A number of variations of this method are shown on Plate 4, in some of which sacks of earth are employed, permitting the use of a smaller amount of material and more rapid raising of the levees. The sacks placed on the water side are also less susceptible of injury from wave wash than the surface of the new earth topping. (See Fig. 10.)

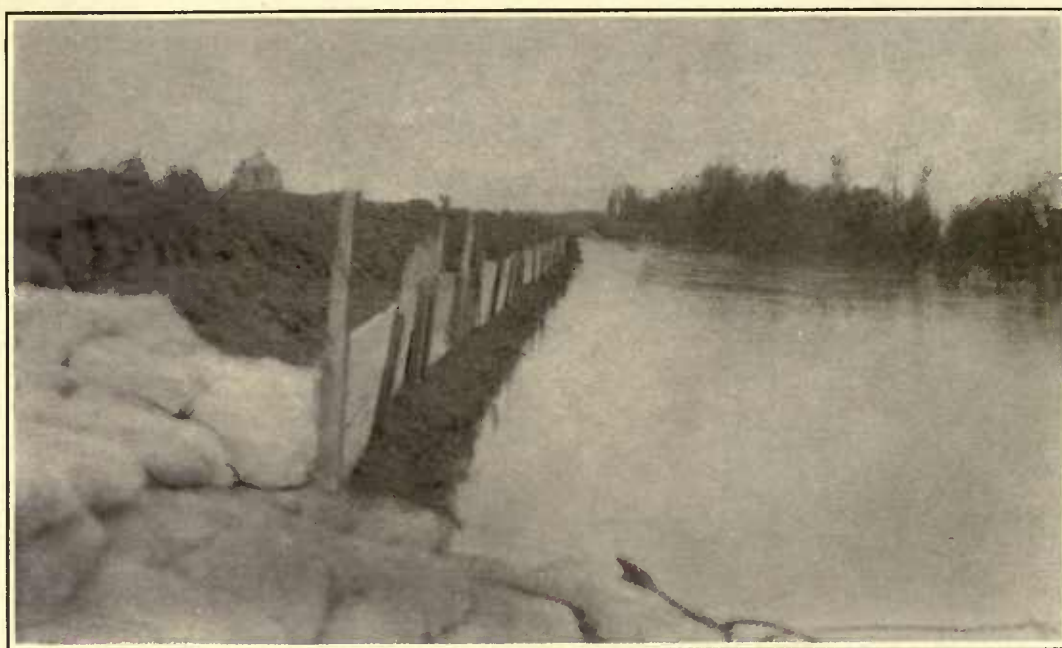
FIGURE 11 — Levees of Fifth Louisiana District above Natchez, topped with wash-boards, backed with earth. 1-inch boards nailed to 2 x 4 stakes. Barge of Mississippi River Commission in background placing wash-boards from berm. Sack revetment in foreground.

Wash-boarding was extensively used also, as shown in Section 5, backed with a small section of earth fill. The wash-boards were usually cheap 1-inch lumber, but afforded some protection against wave wash. (See Fig. 11.)

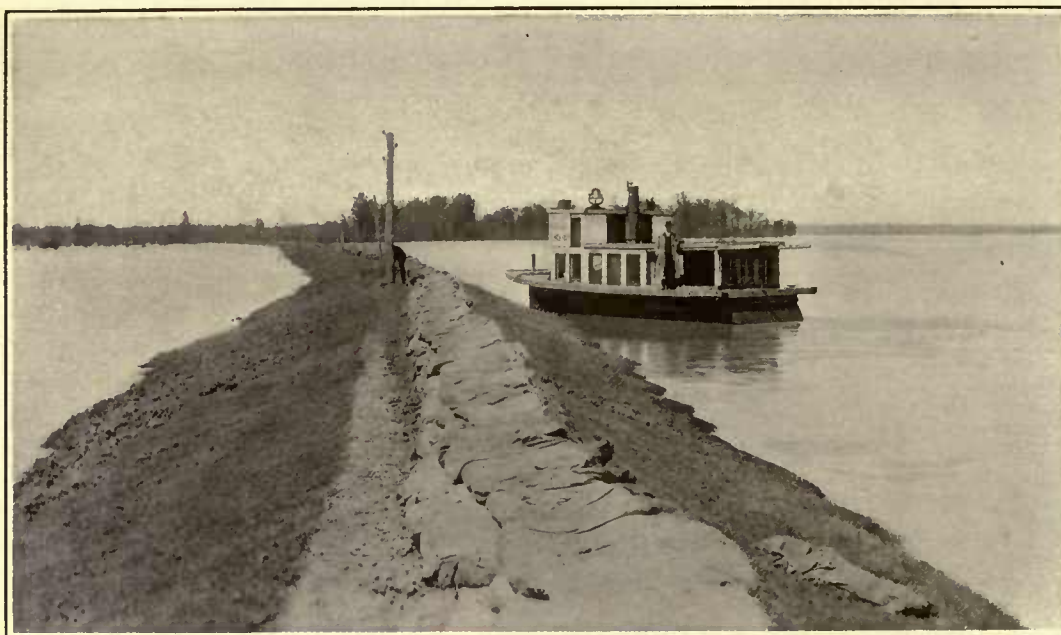
FIGURE 13—Lower St. Francis levee 10 miles below Memphis, Tenn. Topped with double tier of sacks. This levee held till topping was actually overtopped.

Any of these temporary methods of topping levees with such a narrow width are not apt to be efficient in a prolonged flood. That they can hold, however, for a limited time is well shown by the fact that the topping raised the water at the Reel Foot, lower St. Francis and White River levees 1 foot or more above the crests before the levees broke. On the upper St. Francis levees the water was about $1\frac{1}{2}$ feet above when the breaks began. On the upper Tensas District in Arkansas, the levees were actually held till the water was $2\frac{1}{2}$ feet above the top and until the temporary work itself was finally overtopped. (See Figs. 12 and 13.)

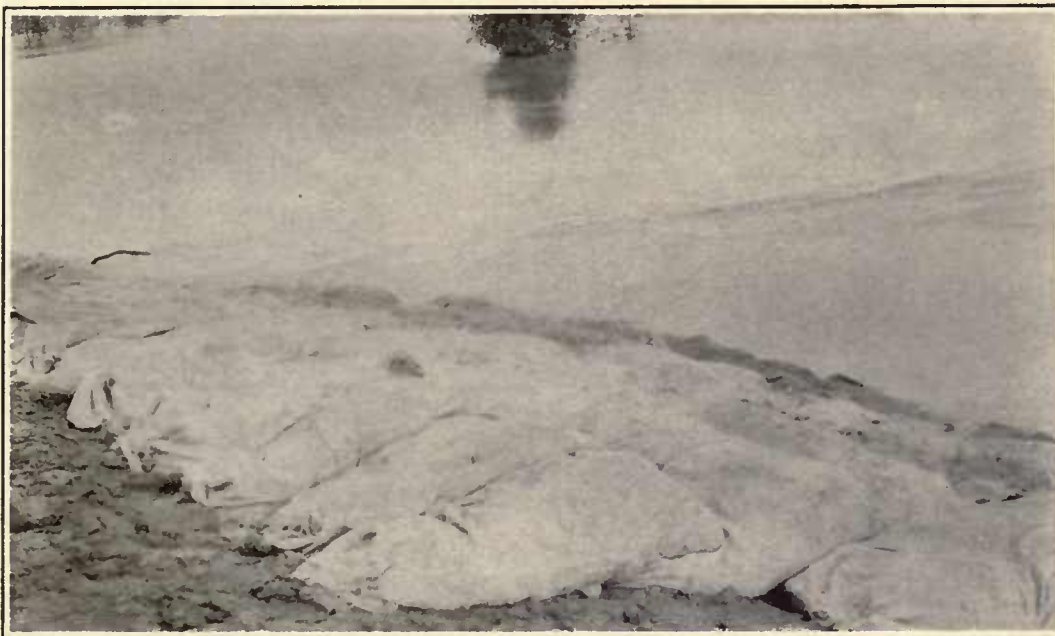
FIGURE 14—Levees of the Fifth Louisiana District at sharp bend above Natchez. Sack revetment to protect against wave wash at point where levee is close to riverbank and completely exposed, due to absence of timber on berm.

The tendency for failure from wave wash appears in general to be much less along the Mississippi than along the Sacramento River. The Mississippi River levees, chiefly because of the shifting channel and caving banks, are generally located a considerable distance back from the river bank, and as the berm is covered with a dense growth of trees and underbrush, there is little exposure to wave wash. The river is so wide that constant erosion from steamer wash experienced along the Sacramento River is not evident along the Mississippi River. In California many of the heaviest and most costly levees are back levees located in the flood basins, which during winter storms may be exposed to tremendous wave action for many hours. The Reel Foot levee, near Hickman, Kentucky, appears to be the only important failure along the Mississippi River in 1912 from wind action. This levee failed with the water 1 foot above the natural crown from waves undermining the sack topping. There were many places, however, where the levees were located close to the river bank or the berm had been cleared, in which emergency work, to guard against wave wash, had been placed. The two methods in most common use are shown in Sections 1 and 4 on Plate 5. The sack protection is considered much more efficient, though more costly, than the wash-boards. (See Fig. 14.)

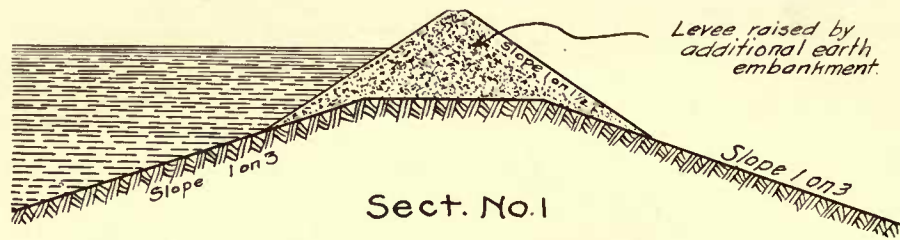
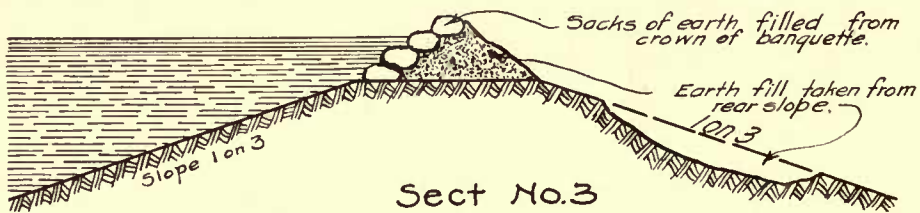
Plate No. 4
Methods Used to Prevent Overtopping of Levees
Haviland & Tibbetts, Engineers, San Francisco
